Title: Surveillance Report on SAVY 4000 and Hagan Nuclear Material Storage Containers Update for Fiscal Year 2020

Surveillance Report on SAVY 4000 and Hagan Nuclear Material Storage Containers Update for Fiscal Year 2020

Executive Summary

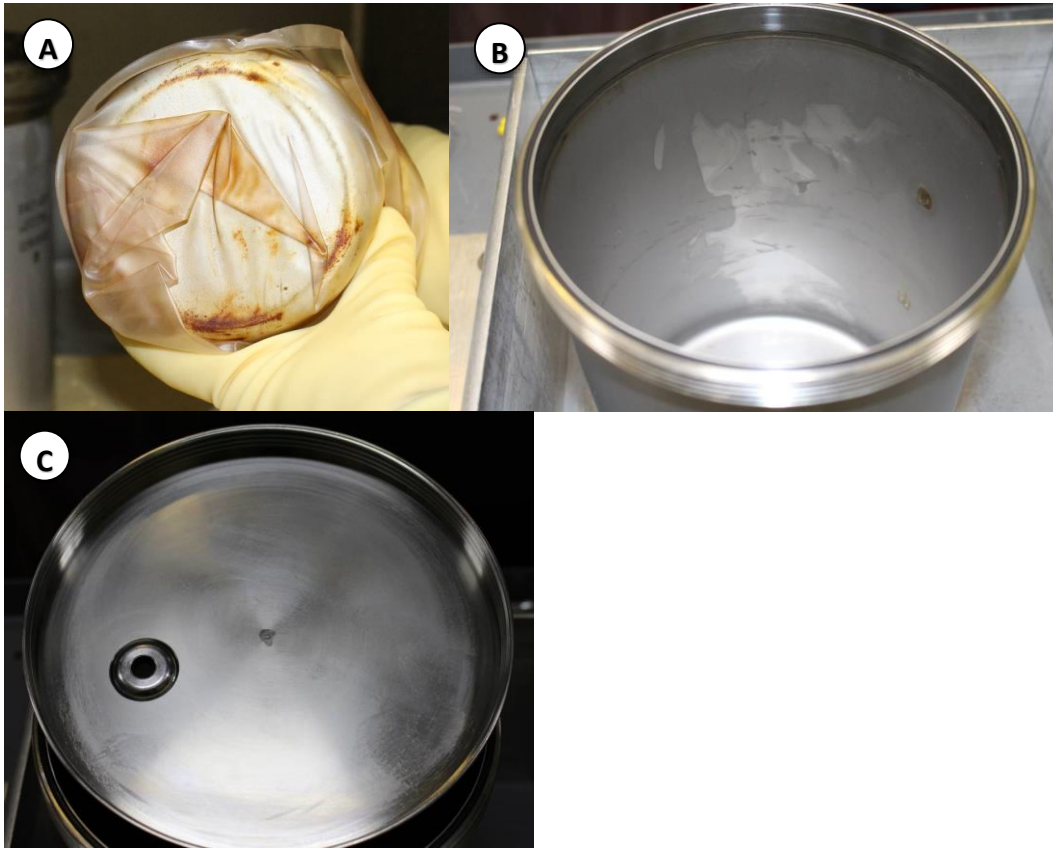
Item content verification:	PSP67156WPHOX
Condition of inner container?	Small corrosion on the outside of the slip lid
Will bag-out bag be replaced before re-pack?	No
Will inner container be replaced before re-pack?	No
Overall package weight after repack:	Not Noted
Comments:	Item will be repacked into SAVY-4000 SN 021805042 B/L repack will have external shielding. Alpha-Beta-Gamma-11 mrem/hr on contact, 4 mrem/hr Neutron on contact (of repacked item)

Figure 4-1 Visual Inspection for 20H11 shows relatively pristine Hagan. (A) Corrosion seen on exterior surface of inner slip-lid container. (B) Inside of Hagan and installed O-ring. (C) Inside of lid and sealing surface.

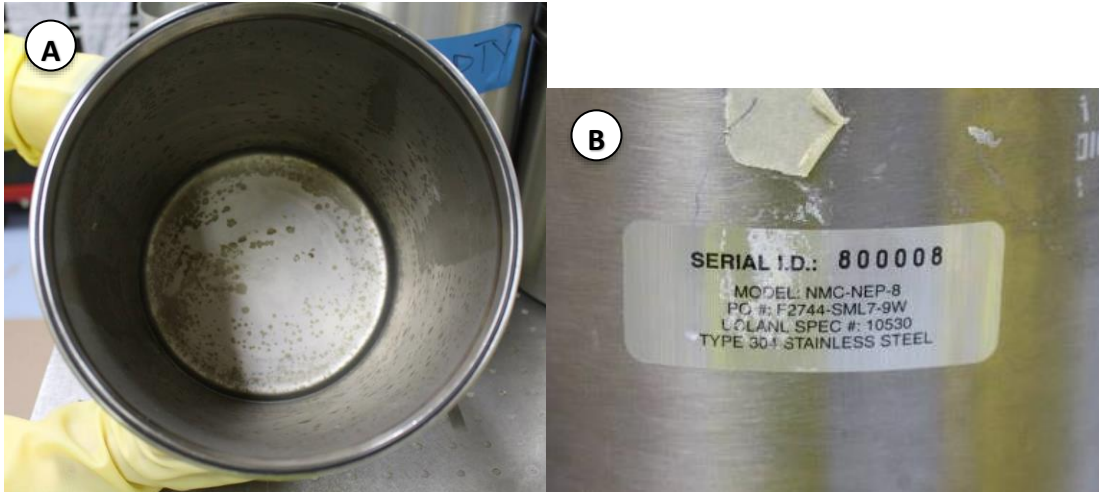
Figure 4-2 Visual inspection of 20H12 (A) Corrosion on inner surface of Hagan container. (B) Metallic label on the container body.

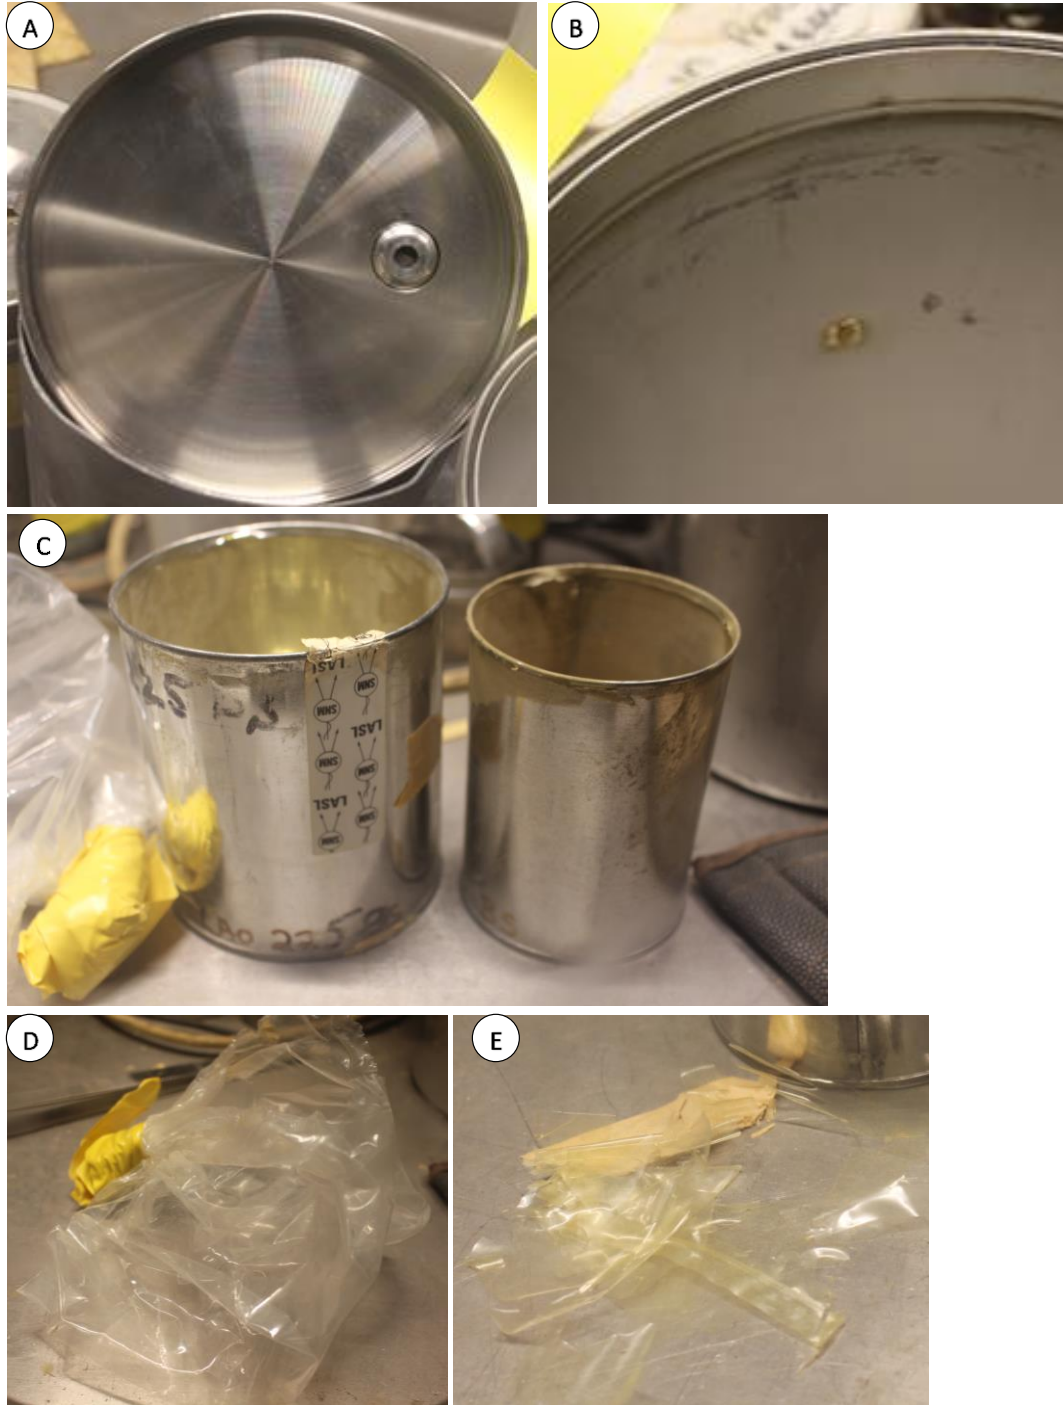
Item content verification:	LAO225BS, MT 56, NM (g) 887
Condition of inner container?	Good, Loaded 7/28/2005
Will bag-out bag be replaced before re-pack?	Yes
Will inner container be replaced before re-pack?	No, Material introduced for production
Overall package weight after repack:	No, Material introduced for production
Comments:	Inner configuration. nested crimp seal cans. Innermost crimp seal was bagged, but PE bag was destroyed. Outer crimp seal container had PE bag that was like new. Hagan introduced. Material used for processing.

Figure 4-3 Visual inspection of 20lofOp1 (A) Condition of Hagan lid is like new. (B) Hagan body has slight discoloration in heat affected zones around welds. (C) Nested crimp-sealed inner containers (D) Polyethylene bag that was placed around outer crimp-sealed container (E) Polyethylene bag that was placed around inner crimp-sealed container had disintegrated.

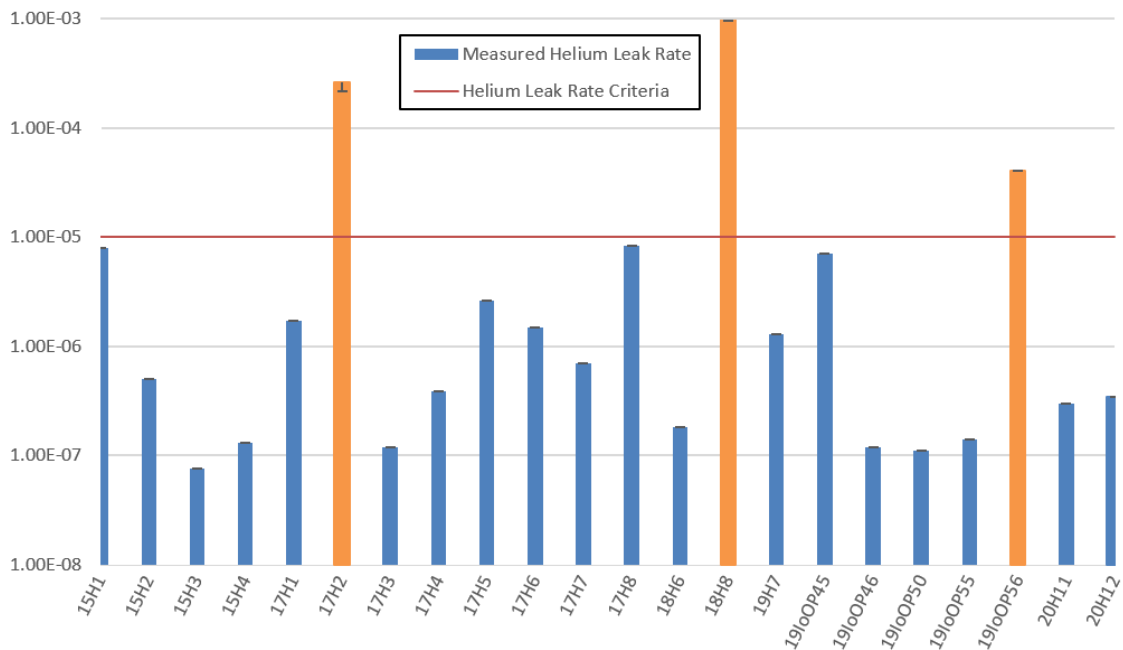
The leakage rate results for the Hagan storage containers are shown in Figure 4-4 for all Hagan containers measured between FY15 and FY20. The measured leakage rates are shown in atm-cc/s of helium at 75 Torr into vacuum. One O-ring failed the leakage test each in FY17, FY18 and FY19, with a measurement above the failure criterion of 1×10^{-5} atm cc/s, possibly resulting from the O-ring hardness being out of specification or the amount of compression set. Due to the Hagan's design and lack of historic data on O-ring thicknesses, it is not possible to acquire a compression set measurement. Because the Hagan is designed with a threaded lid that can be closed to different degrees, it makes it difficult to determine what the gland size is for each container.

Figure 4-4 All available helium leakage rates measured for Hagan container from FY15 to FY20. The red line shows the failure criteria. One container failed each in FY17, FY18 and FY19 (orange bars). Values on y-axis are in atmcc/sec.

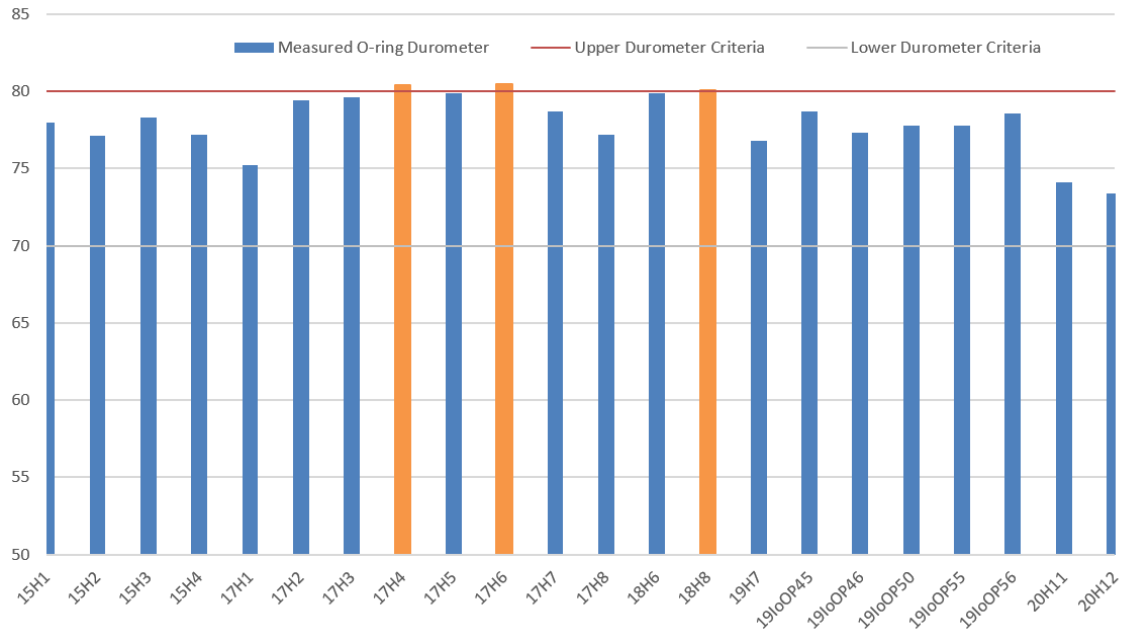
The two Hagan O-rings tested in FY20 had hardness values of 74.1 and 73.4 durometer units, respectively. The durometer results for the Hagan storage container are shown in Figure 4-5 for all Hagan containers measured between FY15 and FY20. The O-ring from container 18H8 exceeded the specification limit of 80.0 durometer units. The O-ring hardness for FY15 through FY20 containers ranged from 73.4 to 80.5 and had an average of 78.0 durometer units. The population of 20 O-rings used as a baseline in the lifetime extension studies have a hardness of 76.8 ± 6.07 durometer units, with a maximum of 78.6 and a minimum of 73.9 durometer units. These baseline O-ring measurements were performed on unused Hagan O-rings that had been stored in plastic bags.

Figure 4-5 All available durometer measurements for Hagan containers from FY15 to FY20. The red and silver lines represent the upper and lower bounds for the hardness, respectively. Two O-rings from FY17 and one O-ring from FY18 failed the hardness criteria (orange bars). The O-ring durometer values on the y-axis are Shore-M hardness values.

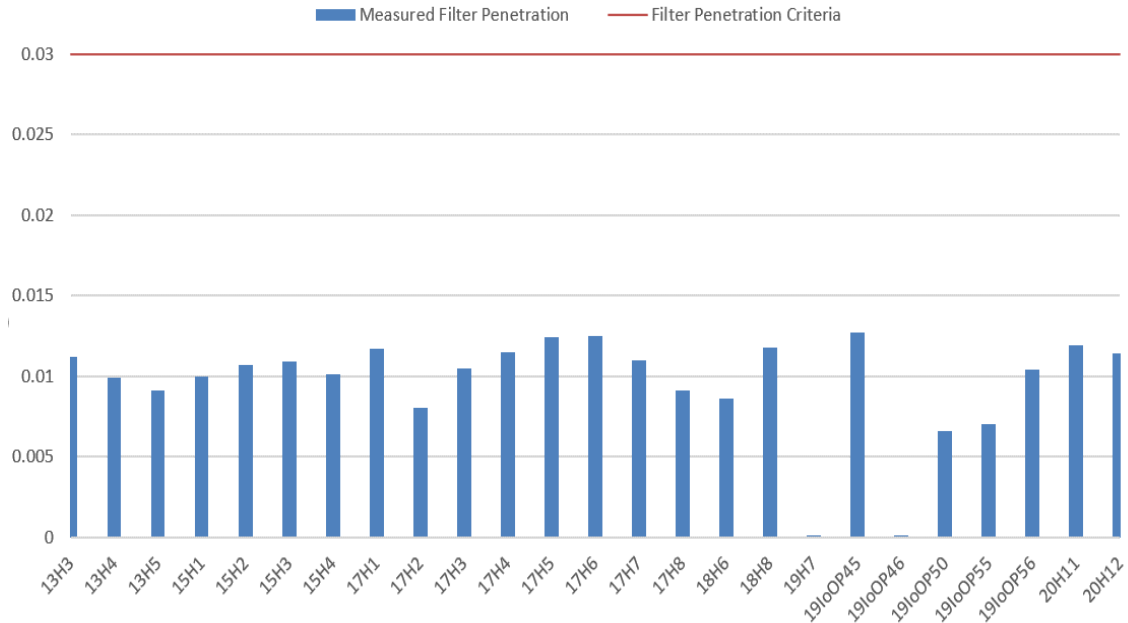
The aerosol data are reported as a percent penetration, also known as the percent leakage. Two Hagan containers were particle penetration tested in FY20 and compared with the results from FY15, 16, 17, 18 and 19 in Figure 4-6. The set of particle penetration measurements obtained between FY15 and FY20 is narrowly distributed and is at least a factor of 2 lower than the requirement. No Hagan filters have failed the particle penetration test.

Figure 4-6. All available filter particle penetration measurements for Hagan containers measured from FY15 to FY20. The red line represents the upper bound for filter penetration. Values on y-axis are the filter efficiency.

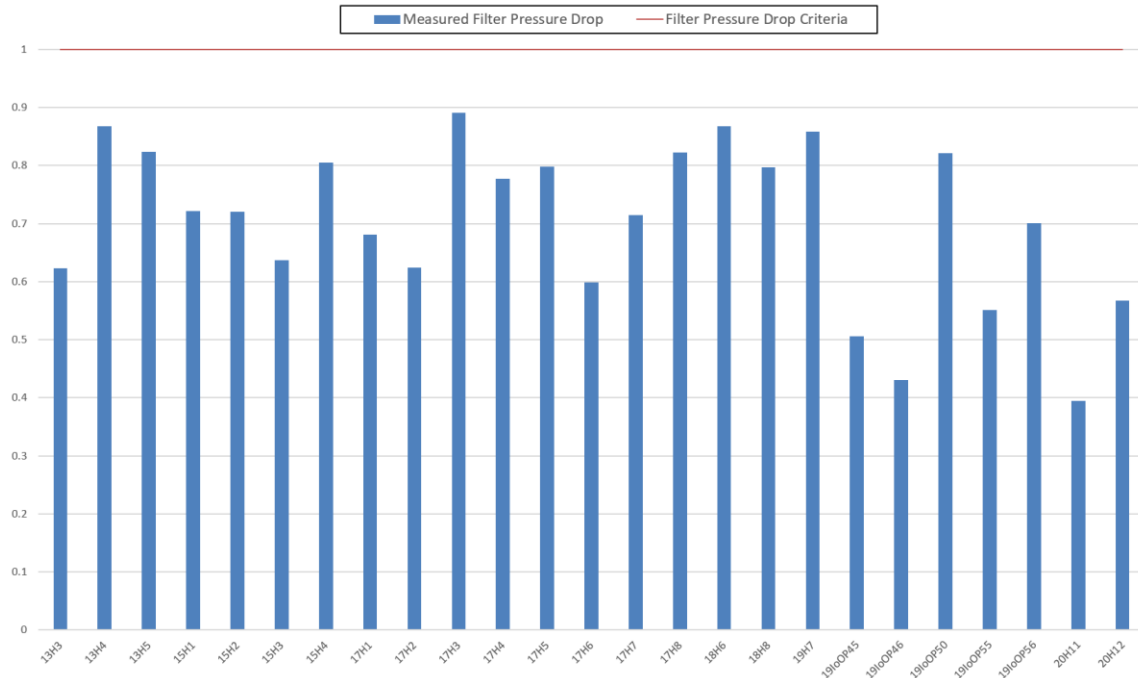
Two Hagan containers were pressure drop tested in FY20 and compared with the results from FY15,16,17,18 and 19 in Figure 4-7. The average pressure drop across Hagan filters for the data collected between FY15 and FY19 is 0.704 in. W.C.

Figure 4-7 All available filter pressure drop measurements for Hagan containers measured from FY15 to FY20. The red line represents the upper bound for filter pressure drop. Values on y-axis are pressure drop in units of inches W.C.

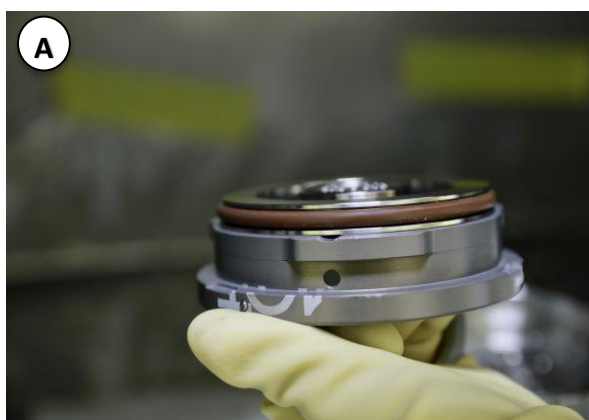
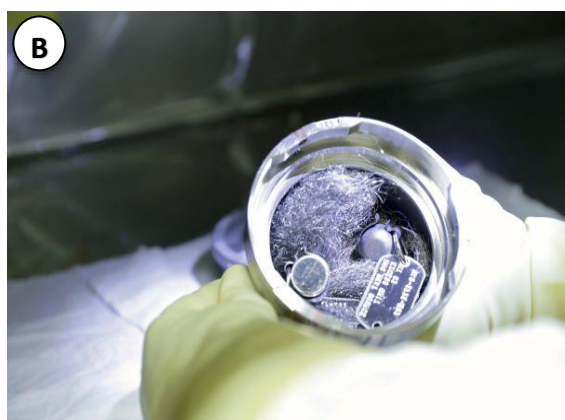
Figure 4-8 (A) The O-Ring in place on the lid. (B) The internal packing configuration of 20S16.

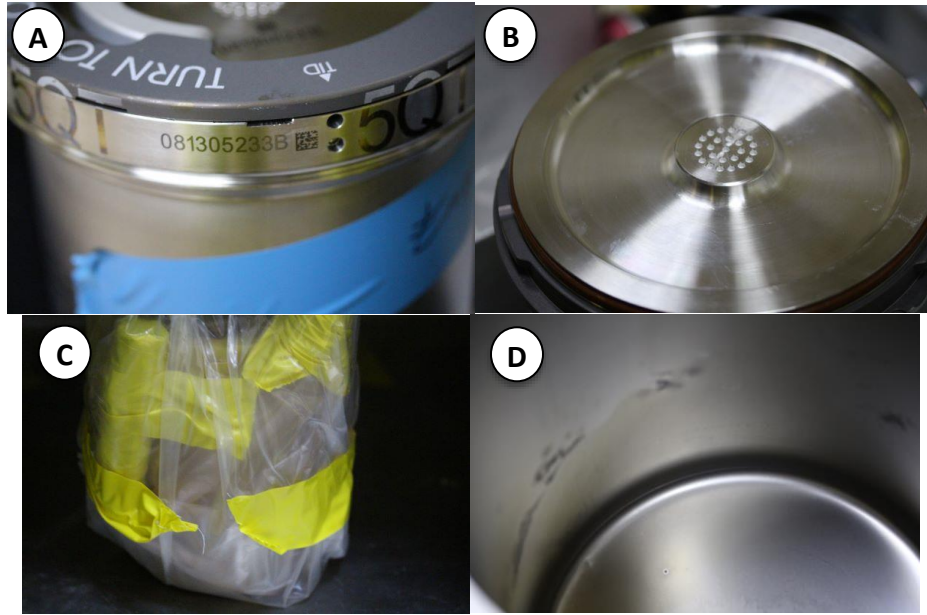
Figure 4-9 Visual inspection results of 20S10 during unpacking. (A) Outside serial number verification of 20S10. (B) Internal face of the lid the filter media appears intact and clean. (C) Internal slip lid placed in double bag-out bags. (D) tape residue on the inside surfaces of the SAVY-4000.

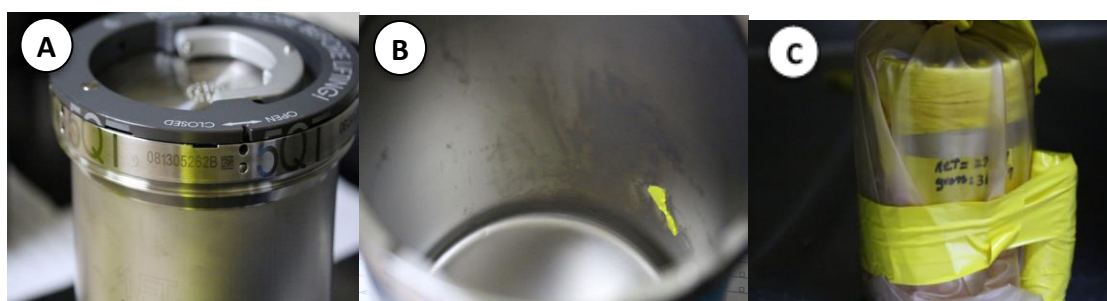
Figure 4-10 Visual inspection results of 20S12 during unpacking. (A) Outer container serial number verification. (B) Internal body with visible tape residue/tape on container walls. (C) Inner package bag-out bag.

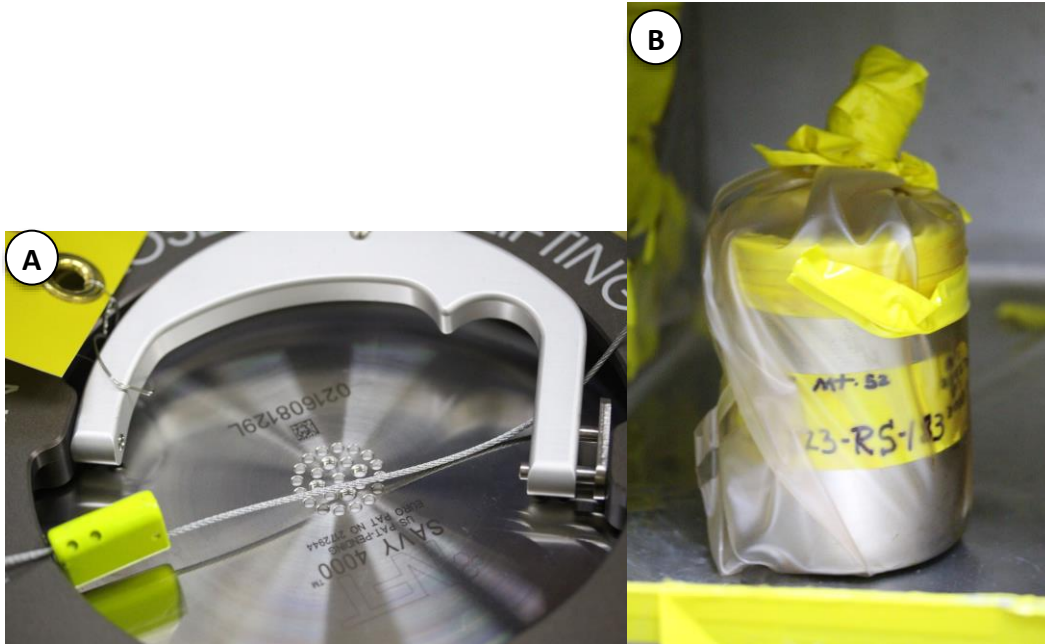
Figure 4-11 Visual inspection results of 20S14 during unpacking. (A) The filter media and diffusion holes are pristine. (B) Inner package appears intact.

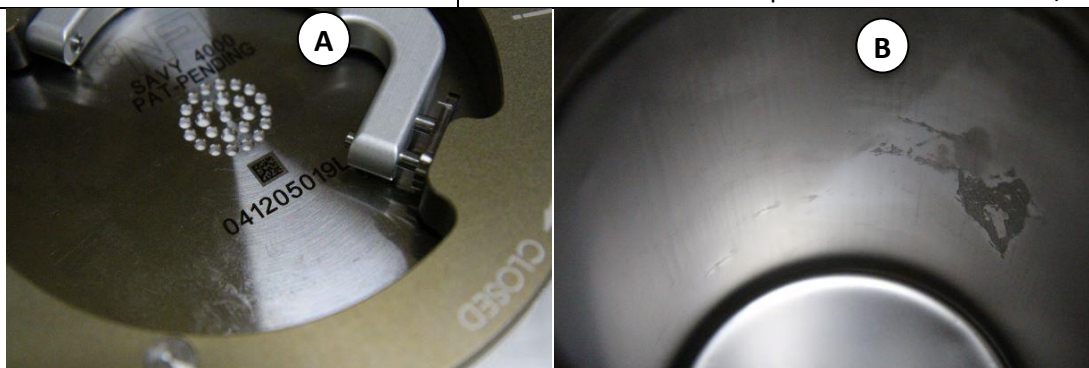
Figure 4-12 Visual inspection results of 20S7(75) during unpacking. (A) Filter media appears clean and serial number verification. (B) Some tape residue on the internal wall of the body of the container.

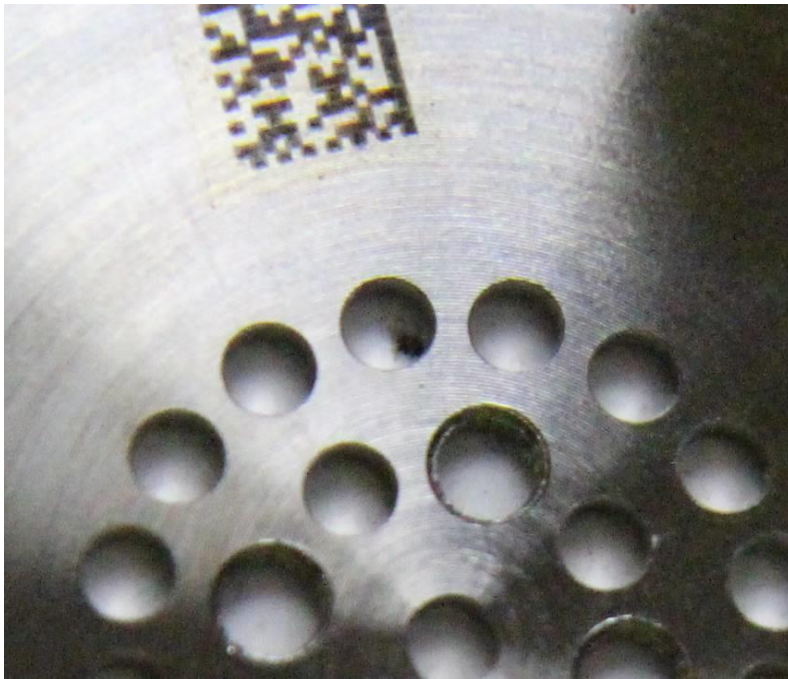
way through this last layer. Analysis is planned to investigate what type of residue is surrounding the damage to attempt to find what caused the damage.

Figure 4-13 Observed damage on top of filter membrane.

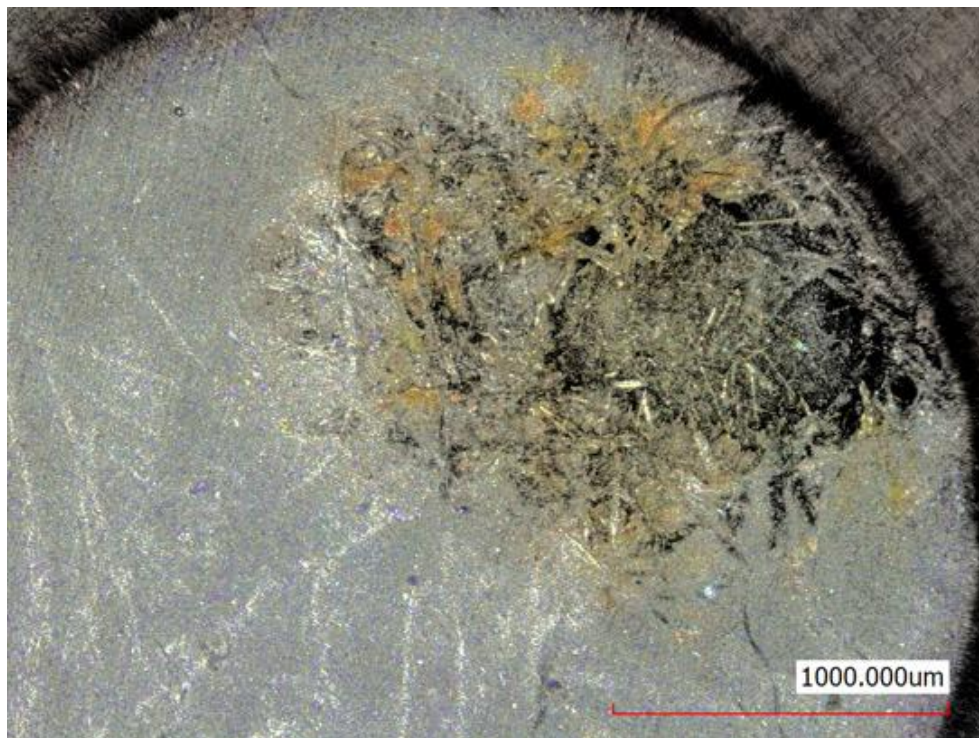
Figure 4-14 Optical images from LCM analysis of damaged filter area.

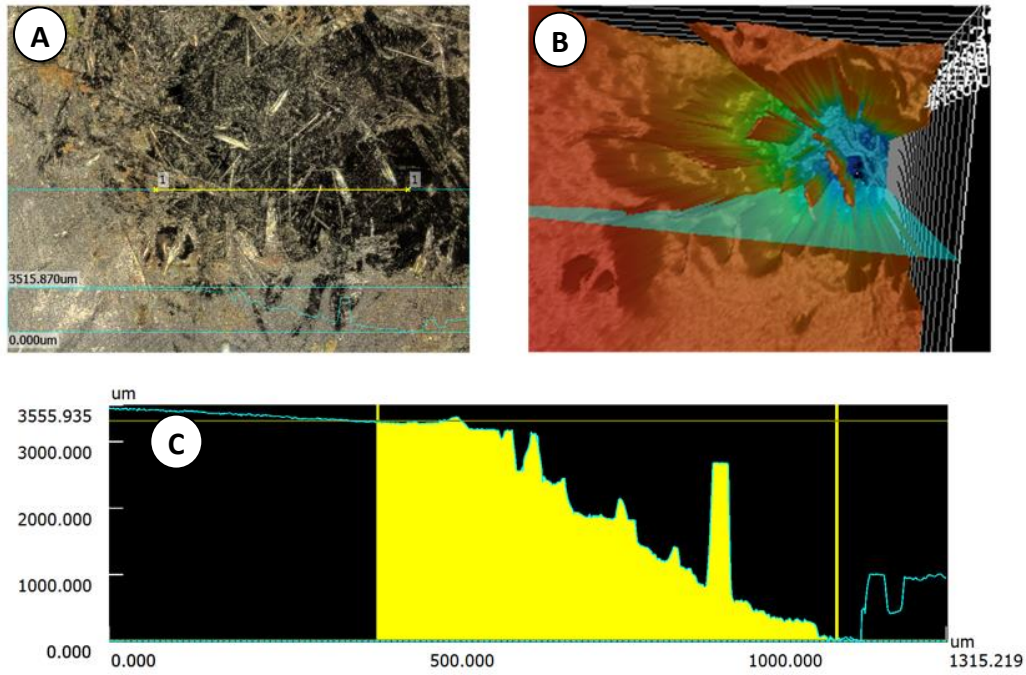
Figure 4-15 LCM data showing the depth (3.2mm) of the damage in the filter membrane and media. (A) Optical image of area scanned by LCM. (B) LCM data shown as a heat map. (C) LCM data as a profile along a line.

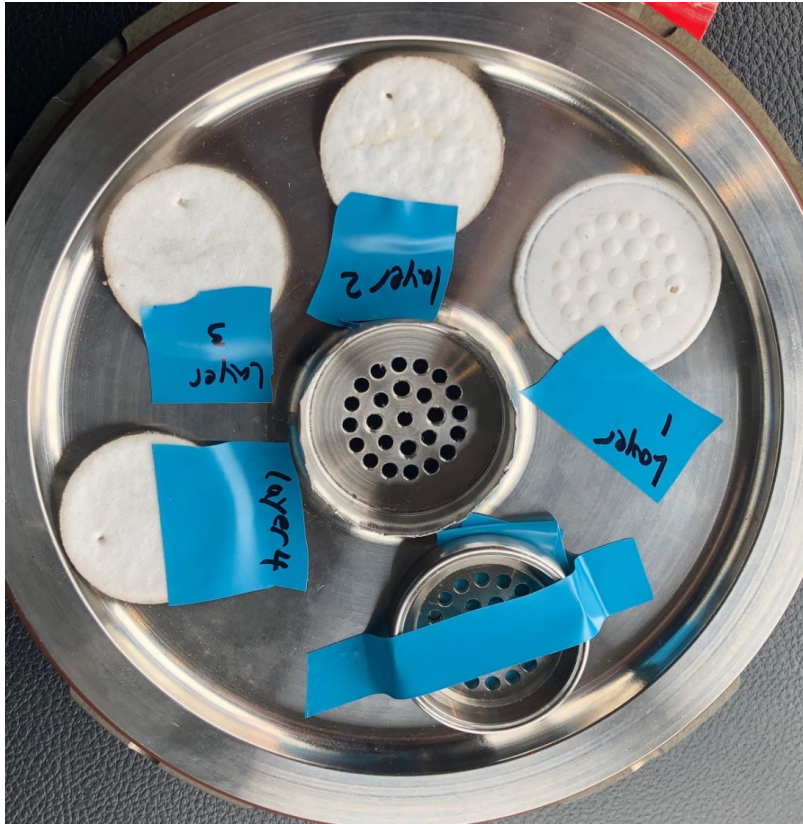
Figure 4-16 Photograph of all of the filter layers. Layer one in the hydrophobic membrane. Layer two through four are the Fiberfrax® filter material. Damage can be seen on all layers.

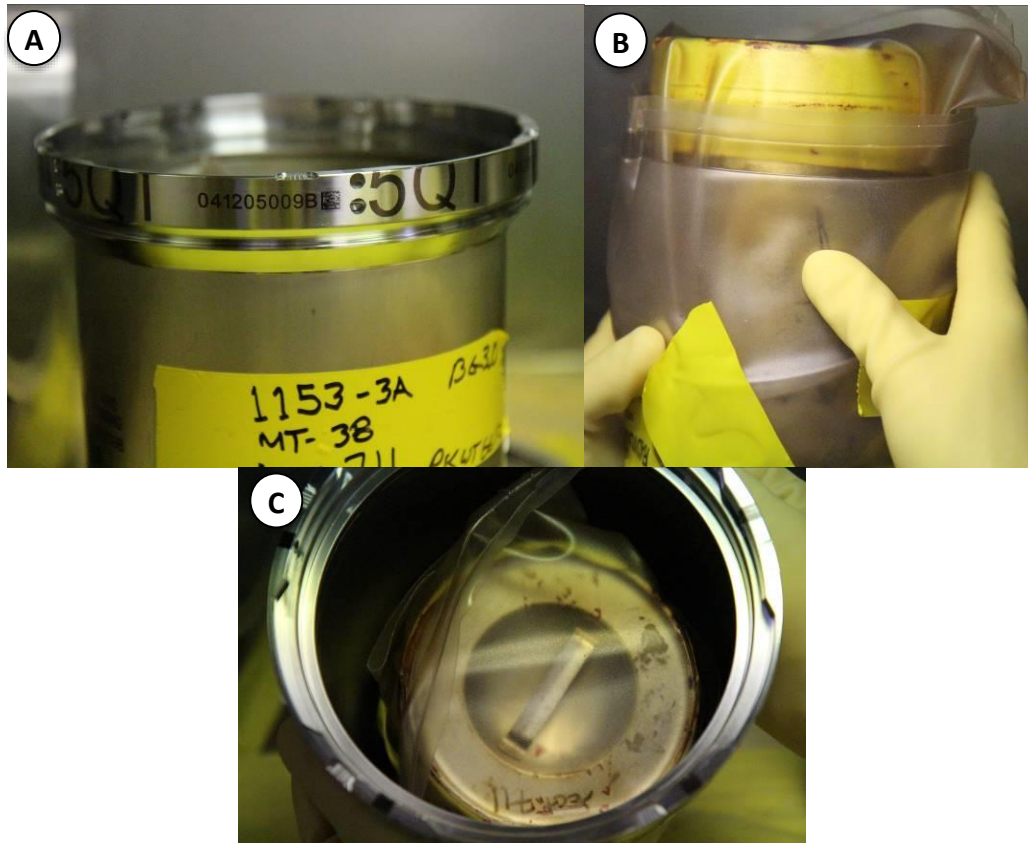
Figure 4-17 Visual inspection of 20S8(108). (A) Serial number verification. (B) Good condition of bag out bag. (C) Evidence of corrosion on the inner stainless steel slip lid container.

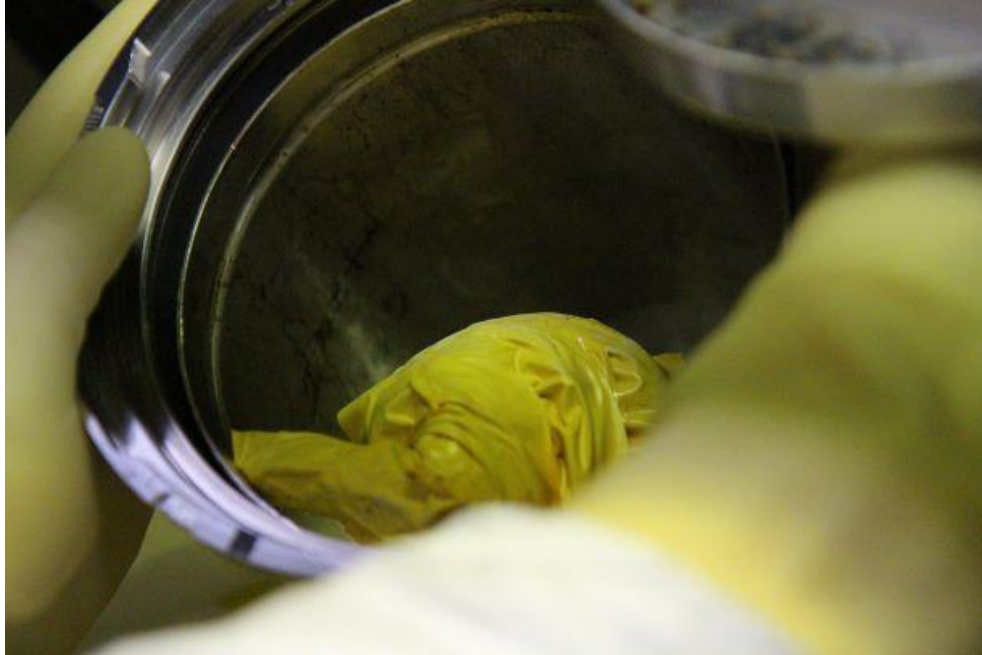
Figure 4-18 Visual inspection results of 20S6(32) during unpacking. General corrosion is visible on the walls of the pewter inner shielding.

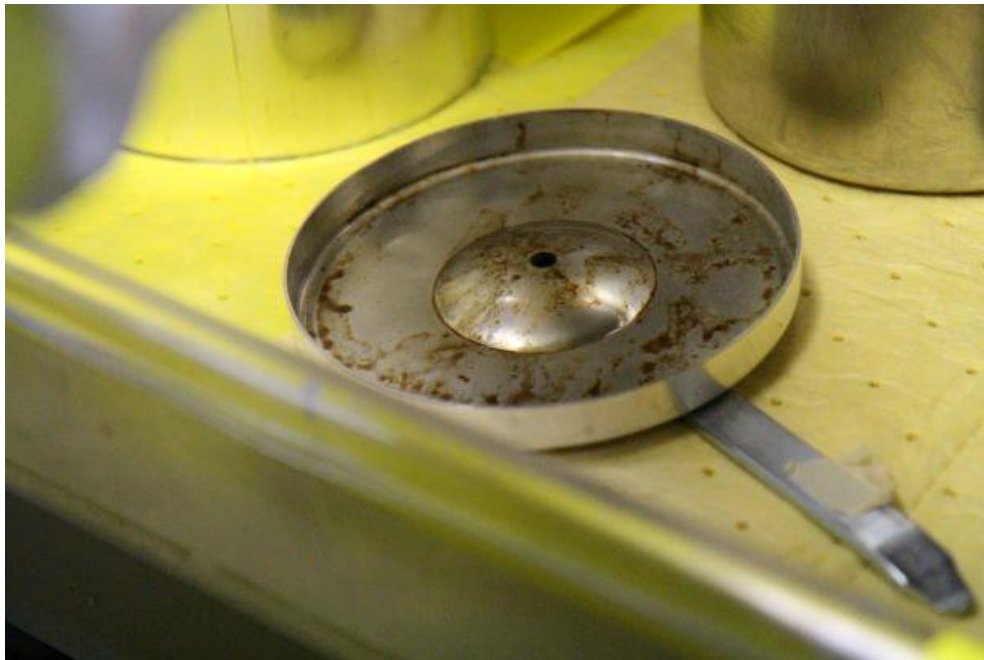
Figure 4-19 Visual inspection results of 20S6(32) during unpacking. Corrosion on underside of lid of the pewter shielding inner container.

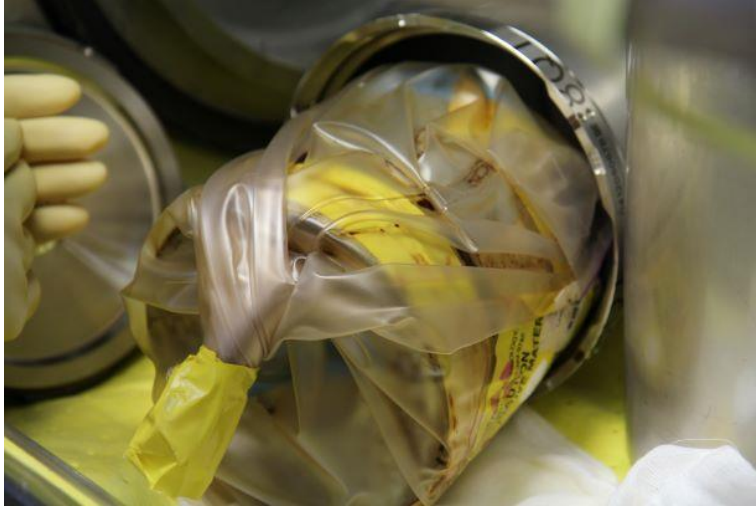
Figure 4-20 Visual inspection results of 20S9(174) during unpacking. Brown plasticizer can be seen inside of the bag-out bag.

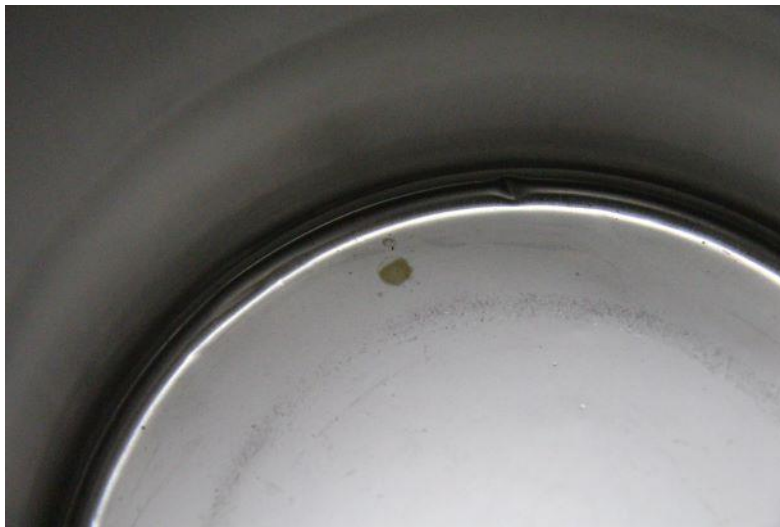
Figure 4-21 Visual inspection results of 20S9(174) during unpacking. A small dent was found on the bottom radius of the SAVY body. A small amount of residue can be seen in the bottom of the SAVY.

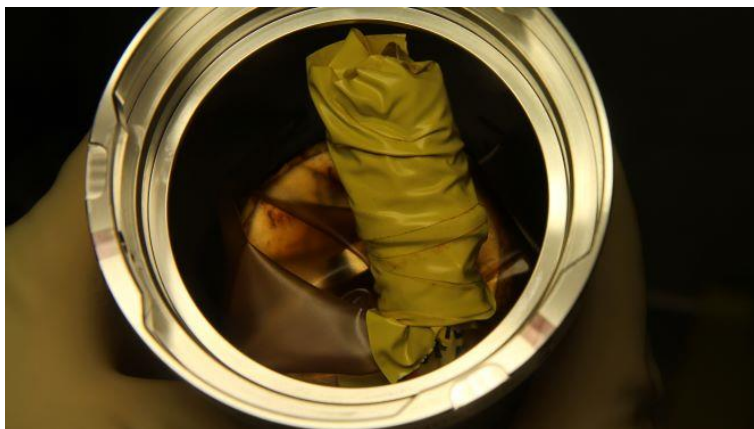
Figure 4-22 Visual inspection results of 20S9(132) during unpacking. The inner packages brown plasticizer can be seen inside of the bag-out bag. Several areas of corrosion on the slip lid can also be seen.

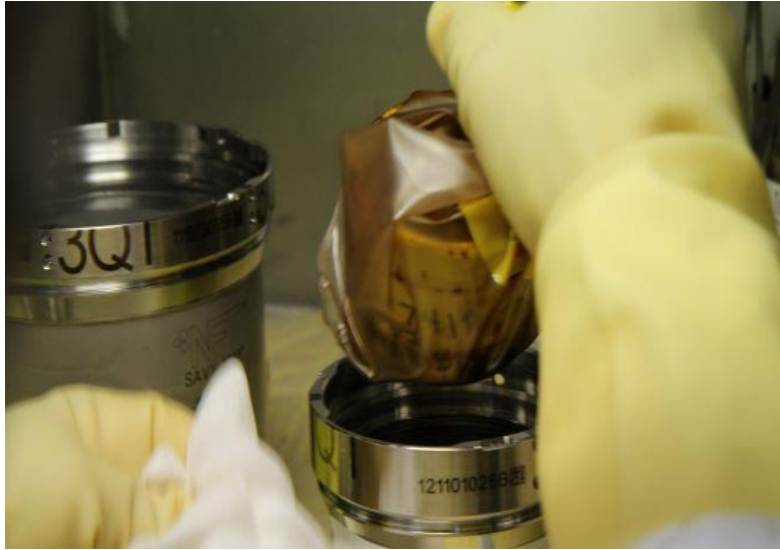
Figure 4-23 Visual inspection results of 20S9(132) during unpacking. General corrosion can be seen around the outside of the slip lid.

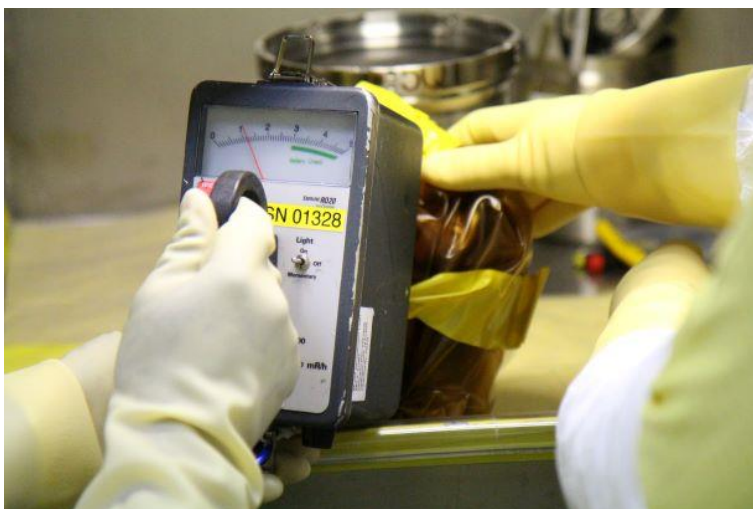
Figure 4-24 Visual inspection results of 20S9(119) during unpacking. Brown plasticizer can be seen inside of the bag out bag.

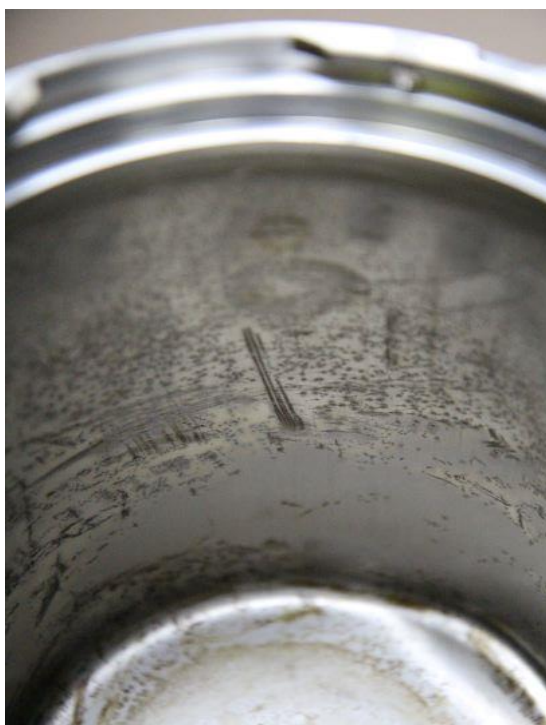
Item content verification:	XBSOX153
Condition of inner container?	Corroded, general corrosion and brown residue on inner container
Will bag-out bag be replaced before re-pack?	No
Will inner container be replaced before re-pack?	No
Overall package weight after repack:	Not measured
Comments:	100 mrem/hr on contact of inner container, this container was replaced with 011305008 B/L. This container is being sectioned for LCM images

Figure 4-25 Visual inspection results of 20S9(119) during unpacking. General corrosion can be seen in the inner surfaces of the SAVY-4000, the most of any container this year.

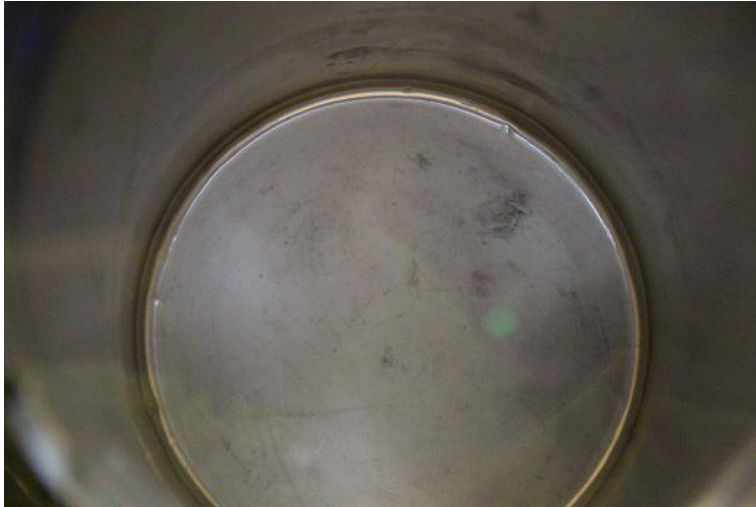
Figure 4-26 Visual inspection results of 20S9(203) during unpacking. Small dents throughout the bottom radius of container body

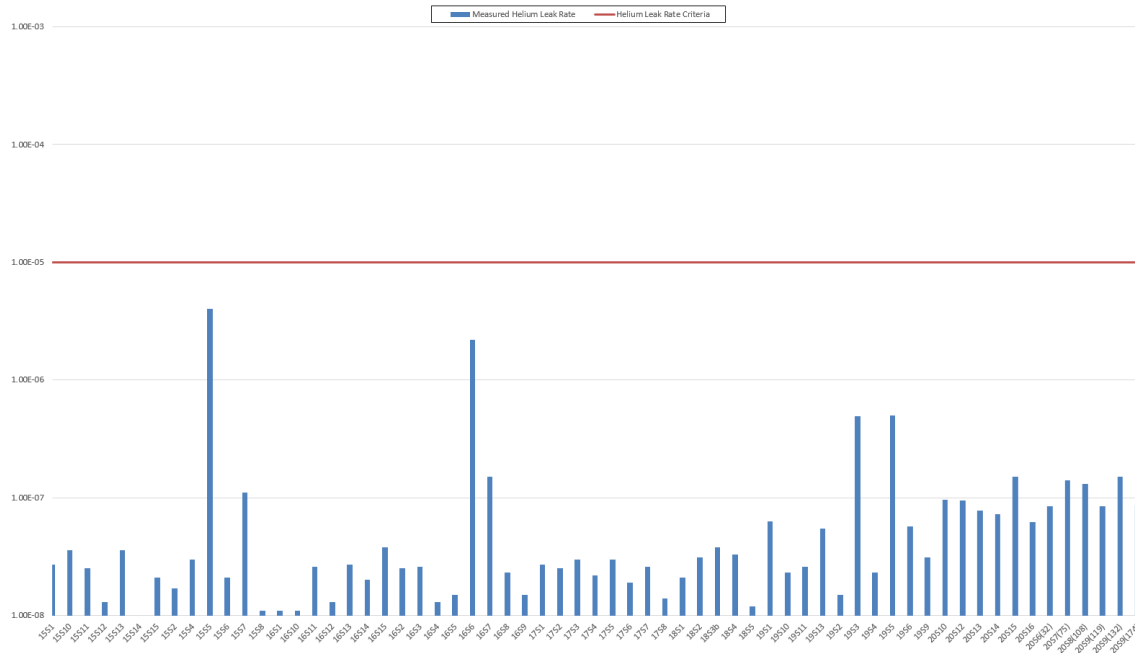
Figure 4-29 Leakage rates for surveillance containers, measured for each container are shown as blue bars with the failure criteria shown with the red line.

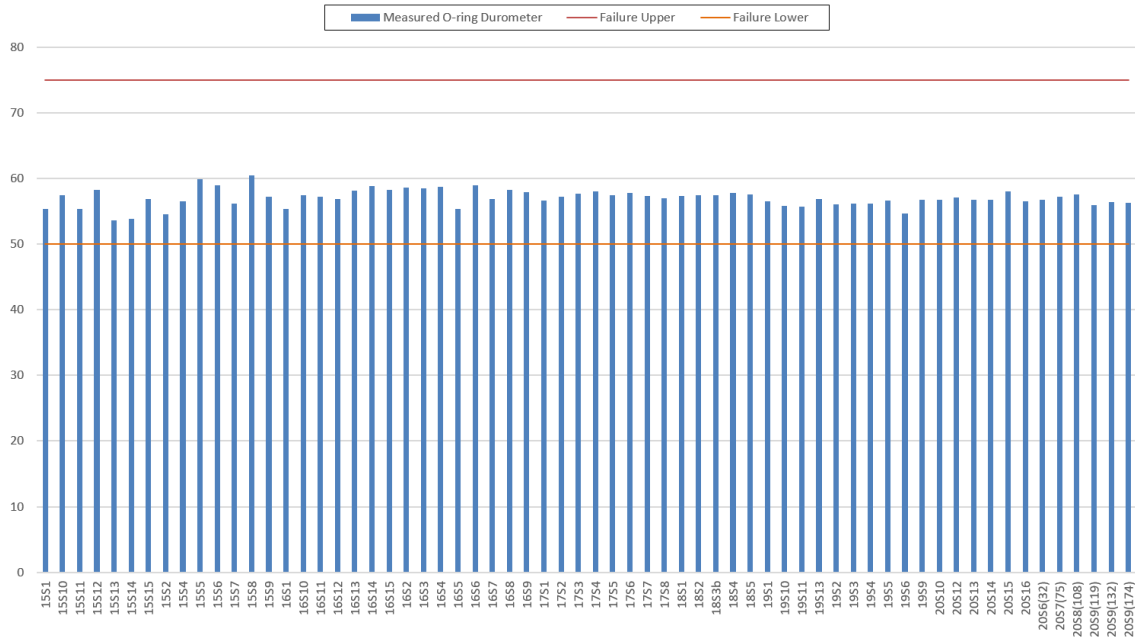
Figure 4-30 Durometer measurements of the surveillance SAVY 4000 O-ring with the red and orange bands showing the upper and lower failure limits, respectively.

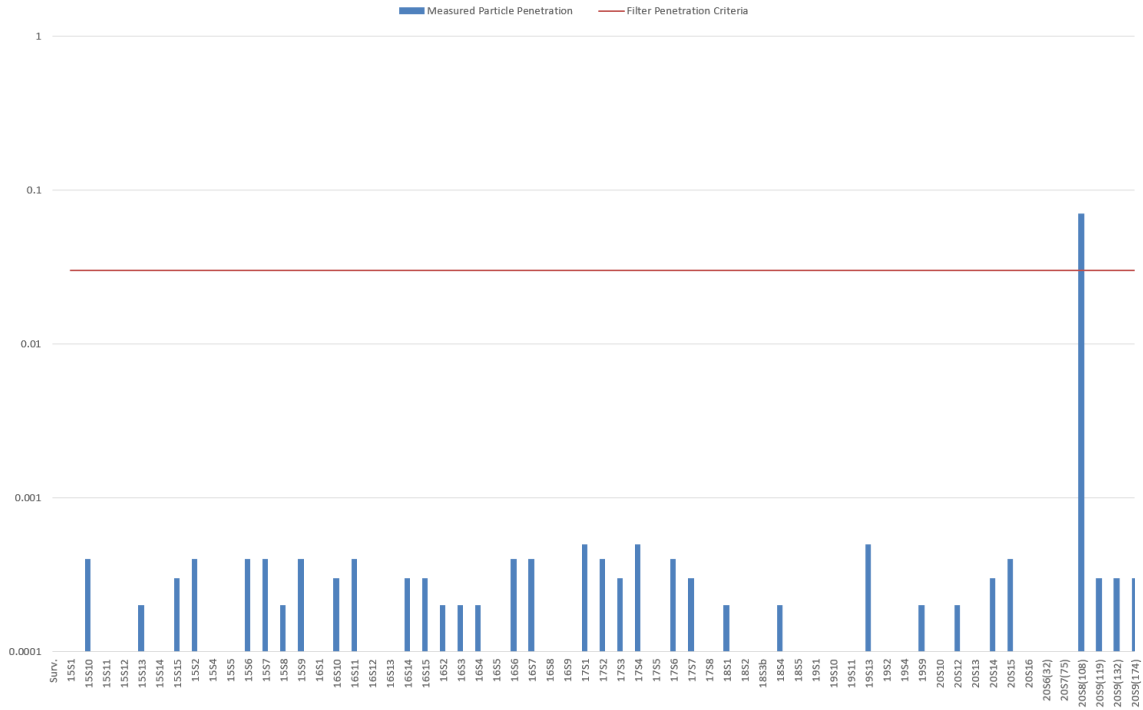
Figure 4-31 Filter particle penetration measurements for SAVY-4000 containers with the red line representing the failure criteria.

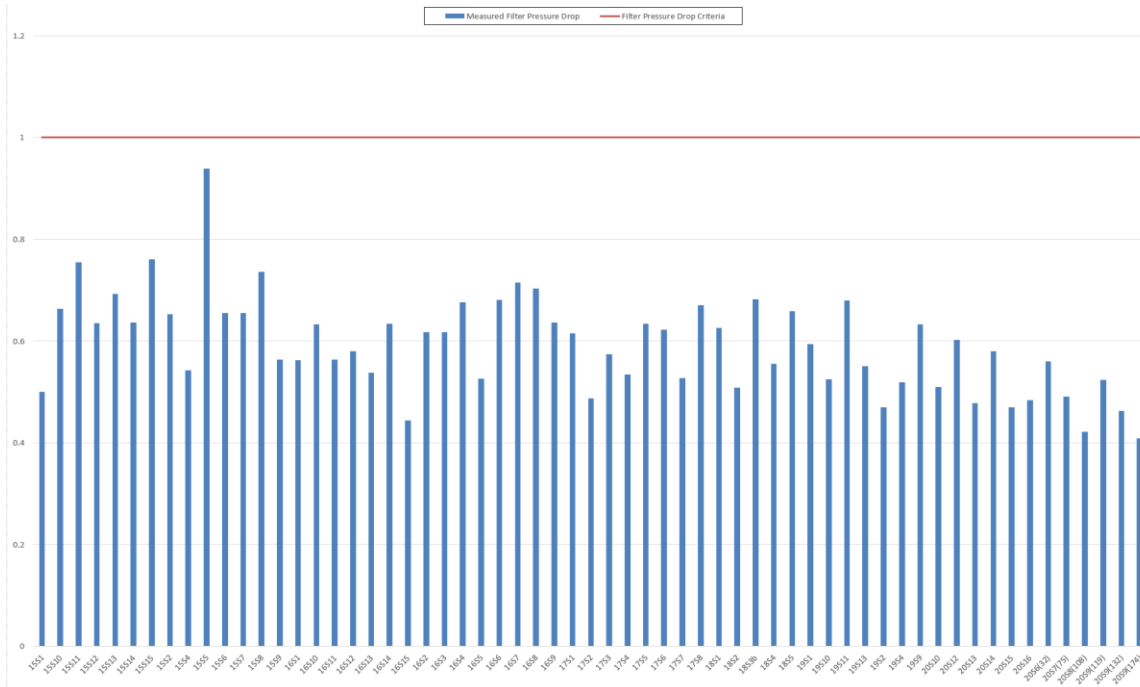
The pressure drop measurements from FY20 have an average of 0.499 in. W.C. ± 0.07 . The results are graphed below in Figure 4-32.
